**Flood Control Project Maintenance
Levee Inspections**
LMA District Cover Sheet
Spring 2016 Levee Inspection Results

City of Sacramento

Spring 2016 Levee Inspection Results

Waterway			Bank	Unit Miles
Unit No. 01 Sacramento River			Left	3.67
	Spring (March - May)	Summer (June - August)	(September - November) Fall	Winter (December - February)
Unit Maintenance Rating (Fall Only)				
Date of Inspection	3/8/2016 - 3/8/2016			
DWR Inspector	Jai Lor			
Accompanied By	Michael Gonsalves City of Sacramento

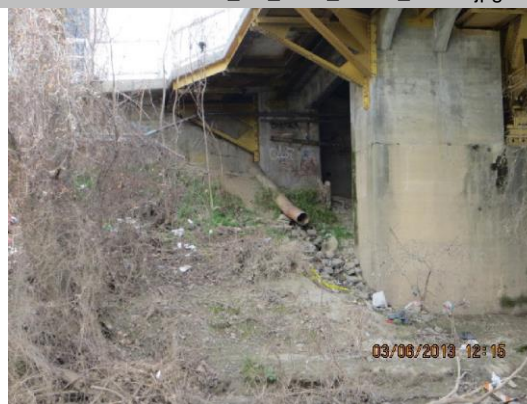
Photo 1 of 2 : UCIP_SP_2016_41421_72750.jpg

LM Start	0.74	Rating **	M	Issue No.	837
LM End	0.74	Issue Type +	En	Location *	WS
Category	Supplemental			GPS Latitude/Longitude	
				Start	End
Item	DWR UCIP Field Study			38.580413 °	38.580413 °
				-121.507166 °	-121.507166 °
DWR ID					
Comment Code					
Inspector Comment					
FS_ID:41421 DS_ID:24905 EP_NO: N/A Repair Type: Non-Urgent Crossing Status: Indicator Found UCIP Comments: Need to contact owner to determine status and permit number for crossing. FIELD_STRUCT_DESC: Corrugated metal drainage pipe through floodwall visible on waterward side. FS Date: 3/6/2013

View of waterward side.

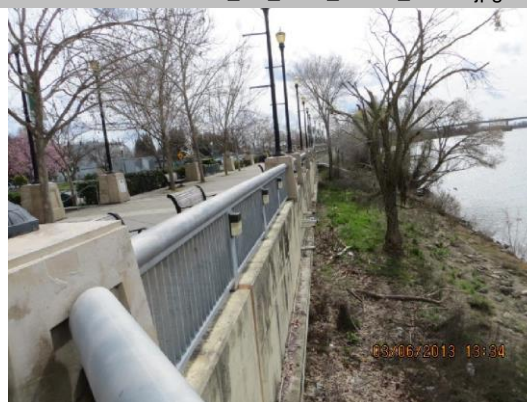
Photo 1 of 2 : UCIP_SP_2016_41422_72754.jpg

LM Start	0.81	Rating **	M	Issue No.	862
LM End	0.81	Issue Type +	En	Location *	WS
Category	Supplemental			GPS Latitude/Longitude	
				Start	End
Item	DWR UCIP Field Study			38.579353 °	38.579353 °
				-121.507560 °	-121.507560 °
DWR ID					
Comment Code					
Inspector Comment					
FS_ID:41422					
DS_ID:24908					
EP_NO: N/A					
Repair Type: Non-Urgent					
Crossing Status: Indicator Found					
UCIP Comments: Need to contact owner to determine status, purpose for lines, and permit number.					
FIELD_STRUCT_DESC: Cluster of conduits through floodwall visible from waterward side.					
FS Date: 3/6/2013

View of levee just downstream from crossings.

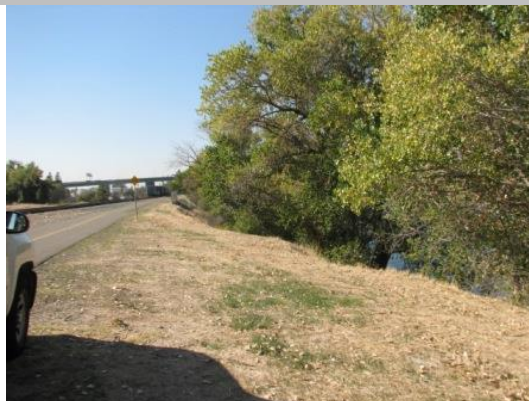
Photo 2 of 2 : SP_2016_NA0005_251_13_20160304_00011.jpg

LM Start	1.16	Rating **	M	Issue No.	13 (cont)	
LM End	1.69	Issue Type +	Ma	Location *	WS	
Category	Earthen Levee			GPS Latitude/Longitude		
				Start		End
Item	Trim / Thin Trees			38.574780 °		38.568757 °
				-121.510191 °		-121.515930 °
DWR ID	DWR_NA0005_01_f_2012_13					
Comment Code						
T2 : Thin trees to allow visibility of the ground and room to flood fight.						
Inspector Comment

Monitor the trees and woody vegetation along the rivers edge. Fall 2013

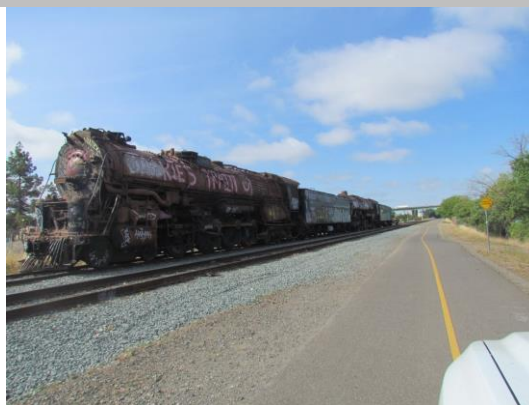
Photo 1 of 2 : SP_2016_NA0005_251_825_20160304_00016.jpg

LM Start	1.20	Rating **	M	Issue No.	825
LM End	1.20	Issue Type +	En	Location *	LS
Category	Earthen Levee			GPS Latitude/Longitude	
				Start	End
Item	Encroachments			38.574347 °	38.574347 °
				-121.510569 °	-121.510569 °
DWR ID	DWR_NA0005_01_s_2015_825				
Comment Code					
EQ : Equipment					
Inspector Comment					
There are two engines on the levee crown at this location.

View of the train on the landward side of the levee looking downstream.
Spring 2015.

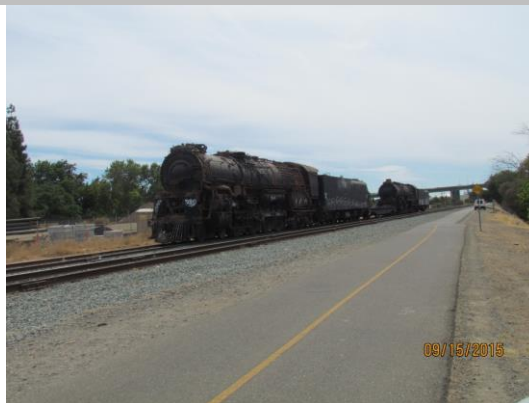
Photo 2 of 2 : SP_2016_NA0005_251_825_20160304_00017.jpg

LM Start	1.20	Rating **	M	Issue No.	825 (cont)
LM End	1.20	Issue Type +	En	Location *	LS

View of the train on the landward side of the levee looking downstream.
Fall 2015.

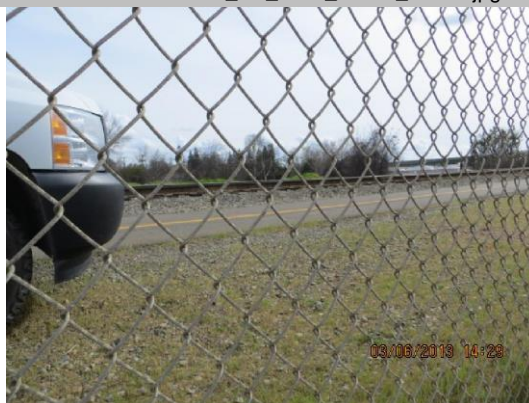
Photo 1 of 2 : UCIP_SP_2016_41425_34145.jpg

FS_ID:41425
DS_ID:21565
EP_NO: 5140
Repair Type: Non-Urgent
Crossing Status: Indicator Found
UCIP Comments: Need to determine more details pertaining to crossing, coordinate with City of Sacramento. Is crossing active?
FIELD_STRUCT_DESC: 30-inch diameter condensing water pipe sleeved through 40-inch diameter pipe 5 feet below the crown, annular space grouted. Anchor blocks on both ends, concrete pipes under pads over pipe under railroad. Cap on the waterward end. A 1.5 foot thick by 8 foot high by 8 foot wide reinforced concrete headwall supported on a 2 foot thick by 5.5 foot wide by 12 foot long concrete footing. An 8 foot high by 64 foot wide apron constructed around the waterward end of the pipe at the waterward shoulder of the levee. (Permit No. 5140, State of California-Department of General Services-1967) 18-inch temporary diameter welded steel pipe sleeved through existing 30 inch used to convey water from construction site. (Permit No. 5745-1967)

View of railroad and bike path located on levee crown--wide levee.

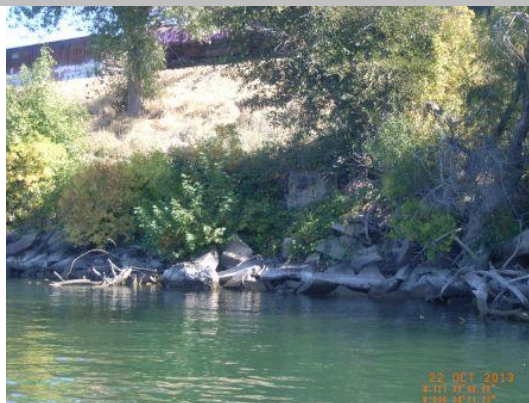
Photo 2 of 2 : SP_2016_NA0005_251_1_20160304_00002.jpg

LM Start	1.31	Rating **	M	Issue No.	1
LM End	1.39	Issue Type +	Ma	Location *	WS
Category	Supplemental			GPS Latitude/Longitude	
				Start	End
Item	2015 USACE Erosion Survey, DRAFT			38.573169 °	38.572277 °
				-121.511998 °	-121.513063 °
DWR ID	DWR_NA0005_01_s _ 2016_1				
Comment Code					
Inspector Comment					
2008 - Oversized levee, should be repaired under maintenance. 2009 - Shallow slumps at the mid bank. 2010 - Some minor erosion at the toe, likely from wave wash. Some new shallow slumps. 2011 - One new tree has fallen. 2013 - Erosion continues on the slope surface, site extended upstream. 2015: No observed changes. [2015 Site ID: SAC_58-5_L]

USACE 2013 Photo #2

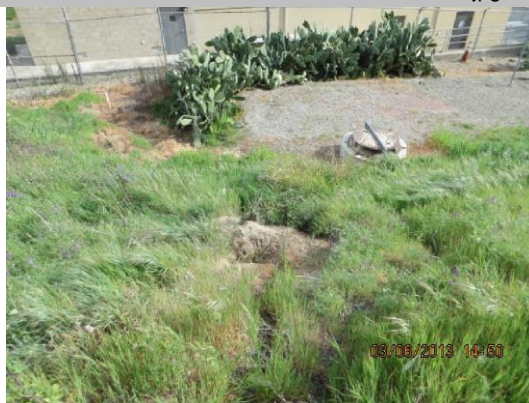
Photo 1 of 2 : UCIP_SP_2016_20105_34067.jpg

LM Start	1.41	Rating **	M	Issue No.	827
LM End	1.41	Issue Type +	En	Location *	WS
Category	Supplemental			GPS Latitude/Longitude	
				Start	End
Item	DWR UCIP Field Study			38.572019 °	38.572019 °
				-121.513082 °	-121.513082 °
DWR ID					
Comment Code					
Inspector Comment					
FS_ID:20105 DS_ID:21580 EP_NO: N/A Repair Type: Non-Urgent Crossing Status: Found UCIP Comments: Dense vegetation limits the inspector's visibility to identify signs of pipe failure (leaks) along the waterward and landward slope. Recommend removing vegetation along pipe alignment to conduct proper inspection of structure and appurtenances. FIELD_STRUCT_DESC: 1 of 3: 6-inch pipe through the levee, 8 feet below the crown. Gate valves on the waterward slope. Manhole located on landward berm. FS Date: 3/6/2013

View of landward side where crossing should be running through.

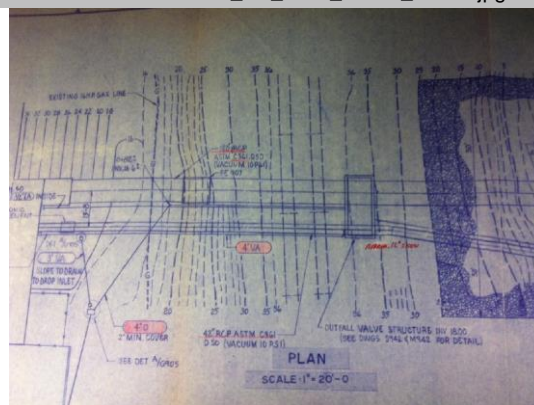
Photo 1 of 2 : UCIP_SP_2016_20087_34024.jpg

Comment Code					
Inspector Comment					
FS_ID:20087 DS_ID:22483 EP_NO: 12196 Repair Type: Non-Urgent Crossing Status: Found UCIP Comments: Vault located on levee crown (bike path) and siphon breaker located on waterward shoulder. Coordinate with City of Sacramento to determine the condition of this crossing and last inspection. FIELD_STRUCT_DESC: 1 or 2: 42-inch RCP wash water intake pipe through levee at approximately 10 feet below crown. Line extends approximately 145 feet waterward from the reservoir to the outfall structure at the waterward shoulder of the levee. Pipe is skewed approximately 12 degrees upstream. Water Intake structure with screen. Waterward slope is armored by rock slope protection. Rock slope protection perimeter exists at river intake. (Permit No. 12196, Sacramento Regional County Sanitation District-1981). Permit 16611 was issued in 1996 to reline the inside of the pipe. FS Date: 3/6/2013

DWG showing 42-inch and 120-inch pipes through levee and connection to outfall valve structure.

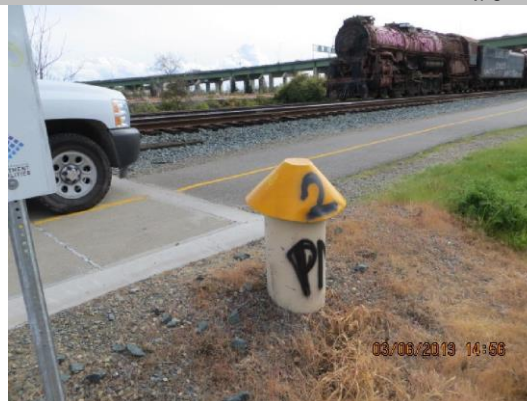
Photo 1 of 2 : UCIP_SP_2016_41280_34051.jpg

Comment Code					
Inspector Comment					
FS_ID:41280 DS_ID:21569 EP_NO: 12196 Repair Type: Non-Urgent Crossing Status: Found UCIP Comments: Check with City of Sacramento to determine last inspection and condition of crossing. Vegetation on waterward and landward slope makes it difficult to inspect and identify any potential leaks visible from surface. FIELD_STRUCT_DESC: 2 of 2: 120-inch RCP outfall pipe extends approximately 117 feet waterward from the reservoir to a reinforced concrete outfall valve structure located in the levee crown. Waterward slope is armored by rock slope protection. Rock slope protection perimeter exists at outlet. (Permit No. 12196, Sacramento Regional County Sanitation District-1977). (Permit No. 12196, Sacramento Regional Sanitation District-1981). FS Date: 3/6/2013

View of levee crown--outlet valve structure located along bike path and siphon breaker on waterward shoulder.

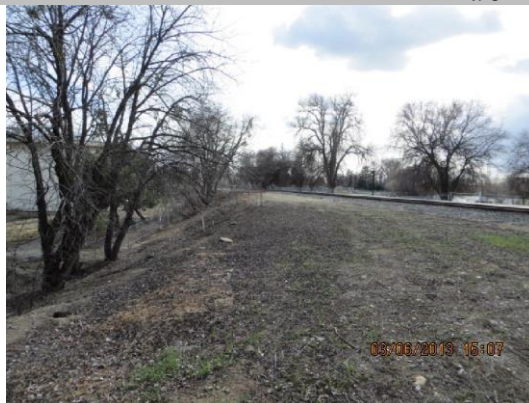
Photo 1 of 2 : UCIP_SP_2016_41442_59560.jpg

View of crossing approximately 110 feet downstream--stand pipes located on landward shoulder.

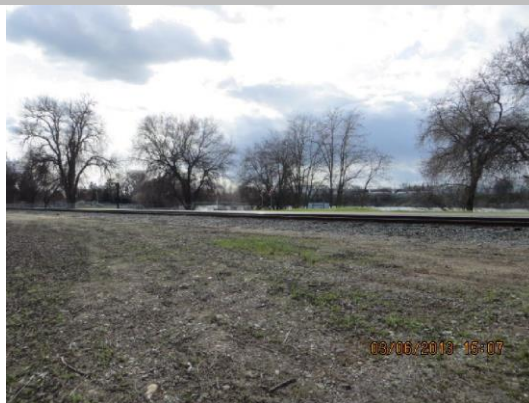
Photo 2 of 2 : UCIP_SP_2016_41442_59559.jpg

View of crossing approximately 110 feet downstream--large sign located on waterward slope.

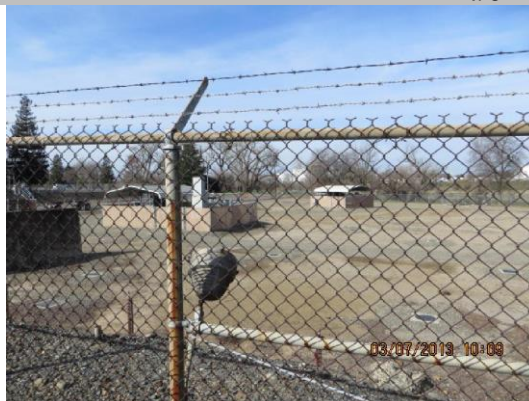
Photo 1 of 2 : UCIP_SP_2016_41282_59575.jpg

Structures present inside lot--site of Ozone Injection and Soil Vapor Extration System for the former Tosco Bulk Fuel.

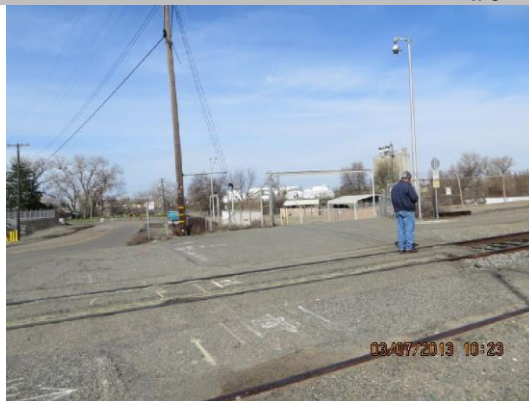
Photo 1 of 2 : UCIP_SP_2016_41427_59507.jpg

View of wide levee crown--old railroad tracks, former Tosco Bulk Fuel Terminal #3493, utility poles, and fire hydrant.

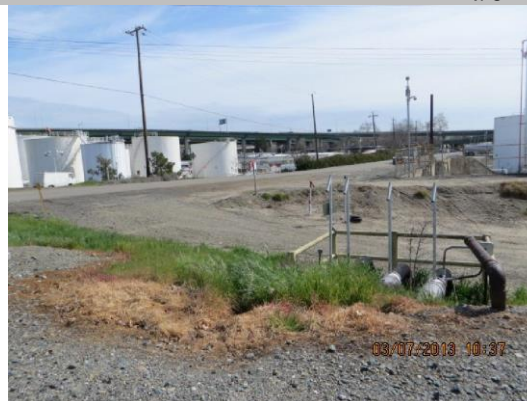
Photo 1 of 2 : UCIP_SP_2016_41452_59525.jpg

View of crossings from levee shoulder.

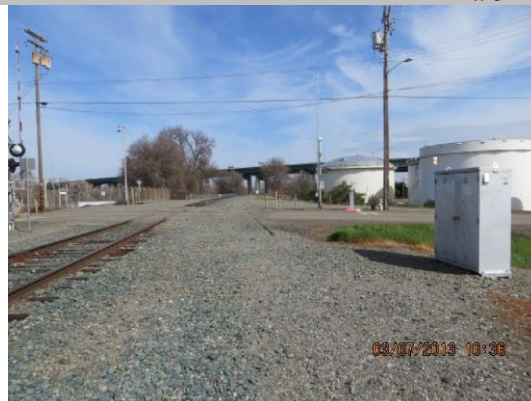
Photo 1 of 2 : UCIP_SP_2016_41448_59511.jpg

View of levee crown looking upstream--rail road traffic signal box located on right side.

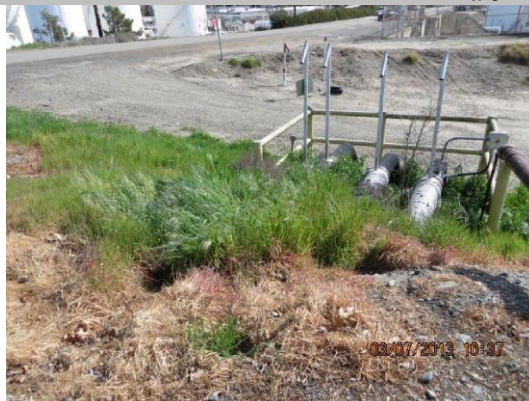
Photo 1 of 2 : UCIP_SP_2016_41449_59518.jpg

View of 4-10 inch pipes through levee located on landward side.

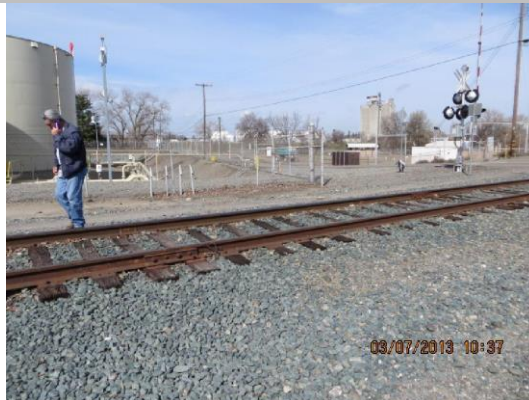
Photo 2 of 2 : UCIP_SP_2016_41449_59517.jpg

View of waterward side--markers visible along chain link fence.

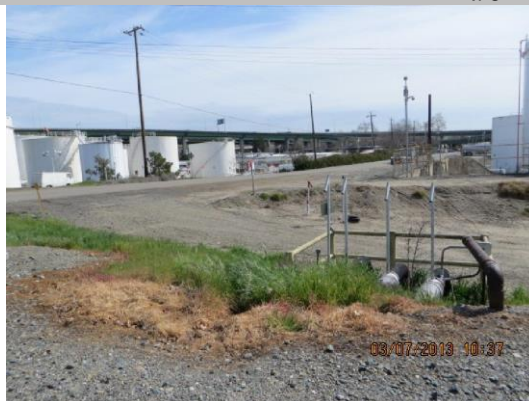
Photo 1 of 2 : UCIP_SP_2016_48322_59521.jpg

View multiple crossings visible on landward side.

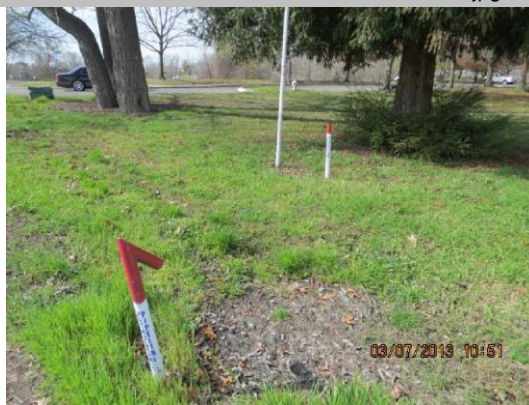
Photo 1 of 2 : UCIP_SP_2016_41457_59529.jpg

LM Start	1.78	Rating **	M	Issue No.	856
LM End	1.78	Issue Type +	En	Location *	LS
Category	Supplemental			GPS Latitude/Longitude	
				Start	End
Item	DWR UCIP Field Study			38.567352 °	38.567352 °
				-121.516102 °	-121.516102 °
DWR ID					
Comment Code					
Inspector Comment					
FS_ID:41457 DS_ID:21576 EP_NO: 4914 Repair Type: Non-Urgent Crossing Status: Indicator Found UCIP Comments: Need records confirming crossing is free of leaks. FIELD_STRUCT_DESC: 8-inch pipe through the levee, 5.0 feet below the crown and along the waterward side to Levee Mile 2.41, for river crossing under the channel. (Permit No. 4914, A, B, C-Standard Oil Co.) FS Date: 3/7/2013

View of waterard side--markers visible through levee.

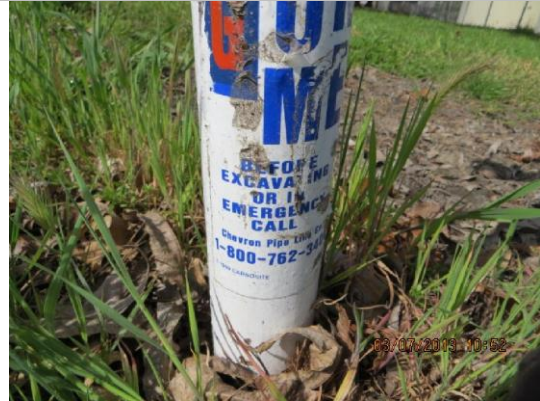
Photo 2 of 2 : UCIP_SP_2016_41457_59528.jpg

LM Start	1.78	Rating **	M	Issue No.	856 (cont)
LM End	1.78	Issue Type +	En	Location *	LS
Category	Supplemental			GPS Latitude/Longitude	
				Start	End
Item	DWR UCIP Field Study			38.567352 °	38.567352 °
				-121.516102 °	-121.516102 °
DWR ID					
Comment Code					
Inspector Comment					
FS_ID:41457 DS_ID:21576 EP_NO: 4914 Repair Type: Non-Urgent Crossing Status: Indicator Found UCIP Comments: Need records confirming crossing is free of leaks. FIELD_STRUCT_DESC: 8-inch pipe through the levee, 5.0 feet below the crown and along the waterward side to Levee Mile 2.41, for river crossing under the channel. (Permit No. 4914, A, B, C-Standard Oil Co.) FS Date: 3/7/2013

Contact information before excation or in case of emergency.

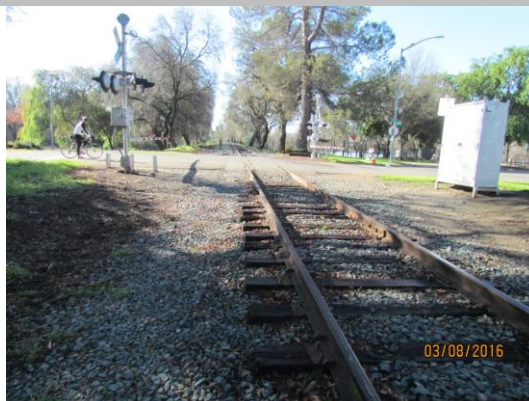
Photo 3 of 4 : SP_2016_NA0005_251_7_20160308_00114.jpg

View of the railroad tracks on the crown of the levee looking downstream at levee mile 1.95. Spring 2016.

LM Start	1.95	Rating **	M	Issue No.	7 (cont)	
LM End	2.34	Issue Type +	En	Location *	CR	
Category	Earthen Levee			GPS Latitude/Longitude		
				Start		End
Item	Encroachments			38.564900 °		38.559460 °
				-121.516253 °		-121.515085 °
DWR ID	DWR_NA0005_01_f_2015_7					
Comment Code						
EQ : Equipment						
Inspector Comment						
Railroad tracks run on crown of levee, paved roadway runs along toe on waterside. This is Miller Park Marina area.

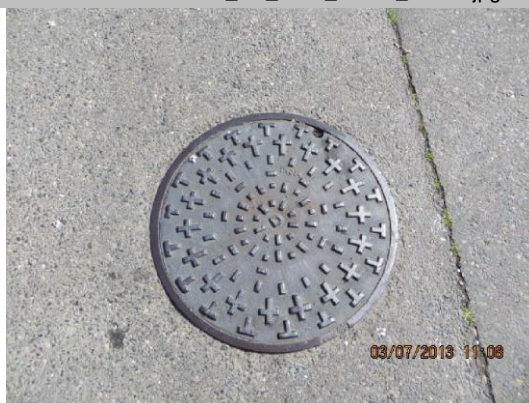
Photo 1 of 2 : UCIP_SP_2016_41430_72757.jpg

LM Start	1.96	Rating **	M	Issue No.	865
LM End	1.96	Issue Type +	En	Location *	CR
Category	Supplemental			GPS Latitude/Longitude	
				Start	End
Item	DWR UCIP Field Study			38.564843 °	38.564843 °
				-121.516246 °	-121.516246 °
DWR ID					
Comment Code					
Inspector Comment					
FS_ID:41430					
DS_ID:21613					
EP_NO: 7434					
Repair Type: Non-Urgent					
Crossing Status: Indicator Found					
UCIP Comments: 2 manholes and sump pump present. Need to update description to confirm if this permit is for Sump-3.					
FIELD_STRUCT_DESC: 4 inch sanitary sewer force main 3/8" steel with 1/8" mortar liner and asphalt coated on the outside. Line runs along the center of the levee for approximately 1700 feet. (Permit No. 7434, City of Sacramento-1972)					
FS Date: 3/7/2013

Manhole present on roadway.

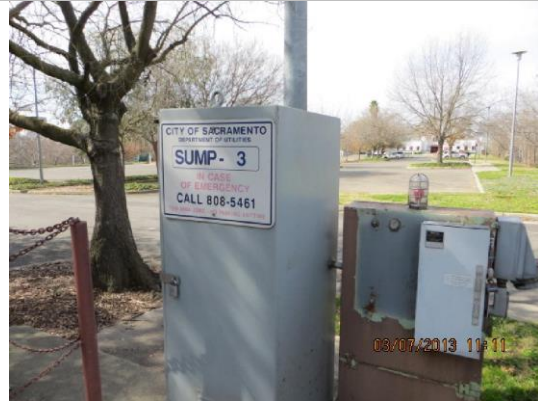
Photo 2 of 2 : UCIP_SP_2016_41430_72756.jpg

LM Start	1.96	Rating **	M	Issue No.	865 (cont)	
LM End	1.96	Issue Type +	En	Location *	CR	
Category	Supplemental			GPS Latitude/Longitude		
				Start	End	
Item	DWR UCIP Field Study			38.564843 °	38.564843 °	
				-121.516246 °	-121.516246 °	
DWR ID						
Comment Code						
Inspector Comment						
FS_ID:41430 DS_ID:21613 EP_NO: 7434 Repair Type: Non-Urgent Crossing Status: Indicator Found UCIP Comments: 2 manholes and sump pump present. Need to update description to confirm if this permit is for Sump-3. FIELD_STRUCT_DESC: 4 inch sanitary sewer force main 3/8" steel with 1/8" mortar liner and ashalt coated on the outside. Line runs along the center of the levee for approximately 1700 feet. (Permit No. 7434, City of Sacramento-1972) FS Date: 3/7/2013

Sump pump station 3.

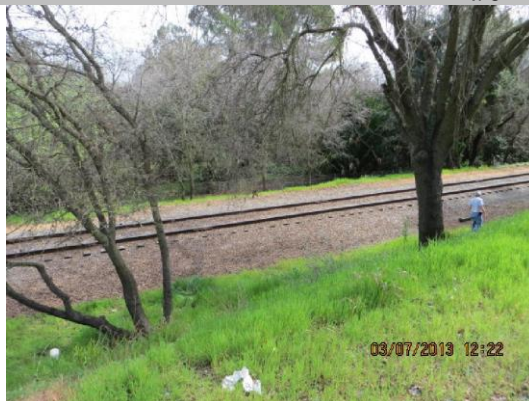
Photo 2 of 2 : UCIP_SP_2016_41293_72759.jpg

LM Start	2.04	Rating **	M	Issue No.	857 (cont)
LM End	2.04	Issue Type +	En	Location *	CR
Category	Supplemental			GPS Latitude/Longitude	
				Start	End
Item	DWR UCIP Field Study			38.563702 °	38.563702 °
				-121.515876 °	-121.515876 °
DWR ID					
Comment Code					
Inspector Comment					
FS_ID:41293 DS_ID:24921 EP_NO: N/A Repair Type: Non-Urgent Crossing Status: Indicator Found UCIP Comments: Need to contact owner to determine type of crossing and status. Need to find out the alignment of crossing. FIELD_STRUCT_DESC: 1 of 4. Crossing found through railroad/levee visible on landward side. FS Date: 3/6/2013

View of landward side.

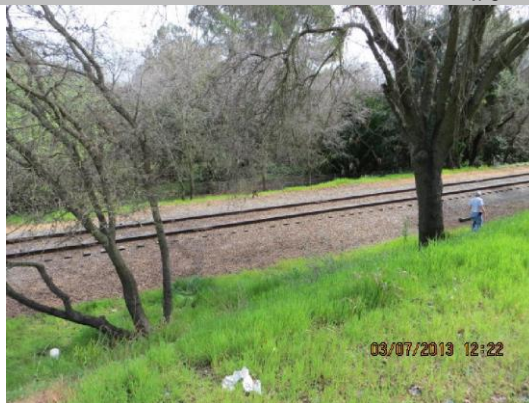
Photo 2 of 2 : UCIP_SP_2016_41294_72761.jpg

LM Start	2.05	Rating **	M	Issue No.	858 (cont)
LM End	2.05	Issue Type +	En	Location *	CR
Category	Supplemental			GPS Latitude/Longitude	
				Start	End
Item	DWR UCIP Field Study			38.563562 °	38.563562 °
				-121.515867 °	-121.515867 °
DWR ID					
Comment Code					
Inspector Comment					
FS_ID:41294 DS_ID:24922 EP_NO: N/A Repair Type: Non-Urgent Crossing Status: Indicator Found UCIP Comments: Need to contact owner to determine type of crossing and status. Need to find out the alignment of crossing. FIELD_STRUCT_DESC: 2 of 4. Crossing found through railroad/levee visible on landward side. FS Date: 3/6/2013

View of landward side.

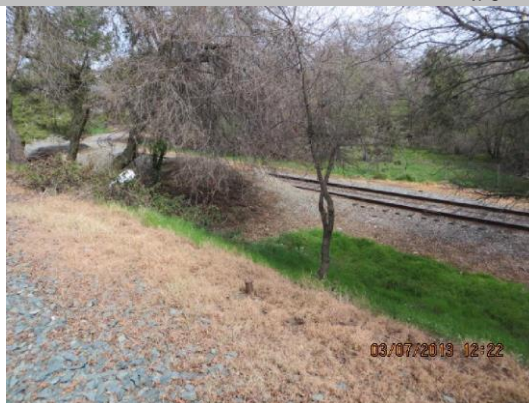
Photo 1 of 2 : UCIP_SP_2016_41295_72764.jpg

LM Start	2.08	Rating **	M	Issue No.	859
LM End	2.08	Issue Type +	En	Location *	CR
Category	Supplemental			GPS Latitude/Longitude	
				Start	End
Item	DWR UCIP Field Study			38.563196 °	38.563196 °
				-121.515833 °	-121.515833 °
DWR ID					
Comment Code					
Inspector Comment					
FS_ID:41295 DS_ID:24923 EP_NO: N/A Repair Type: Non-Urgent Crossing Status: Indicator Found UCIP Comments: Need to contact owner to determine type of crossing and status. Need to find out the alignment of crossing. FIELD_STRUCT_DESC: 3 of 4. Crossing found through railroad/levee visible on landward side. FS Date: 3/6/2013

View of landward side.

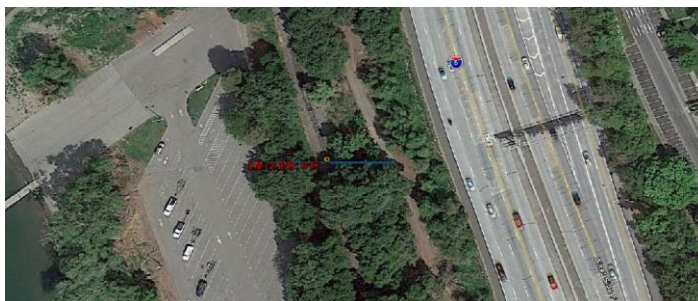
Photo 1 of 1 : UCIP_SP_2016_41431_72800.jpg

LM Start	2.29	Rating **	M	Issue No.	870
LM End	2.29	Issue Type +	En	Location *	CR
Category	Supplemental			GPS Latitude/Longitude	
				Start	End
Item	DWR UCIP Field Study			38.560088 °	38.560088 °
				-121.515150 °	-121.515150 °
DWR ID					
Comment Code					
Inspector Comment					
FS_ID:41431 DS_ID:24925 EP_NO: N/A Repair Type: Non-Urgent Crossing Status: Indicator Found UCIP Comments: Need to coordinate with owner to determine status of crossing. FIELD_STRUCT_DESC: 18 inch storm drain at unknown depth. Crossing information was obtained from Sacramento County GIS records. (Permit No. 1425, 1949) FS Date: 3/6/2013

Approximate alignment through levee provided by the City of Sacramento GIS.

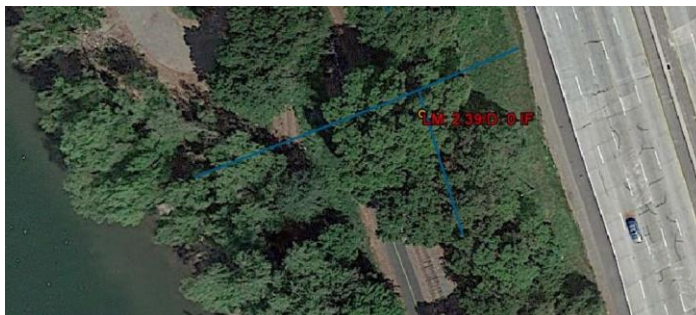
Photo 1 of 1 : UCIP_SP_2016_41433_72801.jpg

LM Start	2.39	Rating **	M	Issue No.	871
LM End	2.39	Issue Type +	En	Location *	LS
Category	Supplemental			GPS Latitude/Longitude	
				Start	End
Item	DWR UCIP Field Study			38.558793 °	38.558793 °
				-121.514460 °	-121.514460 °
DWR ID					
Comment Code					
Inspector Comment					
FS_ID:41433 DS_ID:24926 EP_NO: N/A Repair Type: Non-Urgent Crossing Status: Indicator Found UCIP Comments: Need to coordinate with owner to determine status of crossing. Unable to find crossing in the field. FIELD_STRUCT_DESC: Unknown pipe size through levee. Crossing information was obtained from Sacramento County GIS records. FS Date: 3/6/2013

Approximate alignment for crossing provided by City of Sacramento GIS.

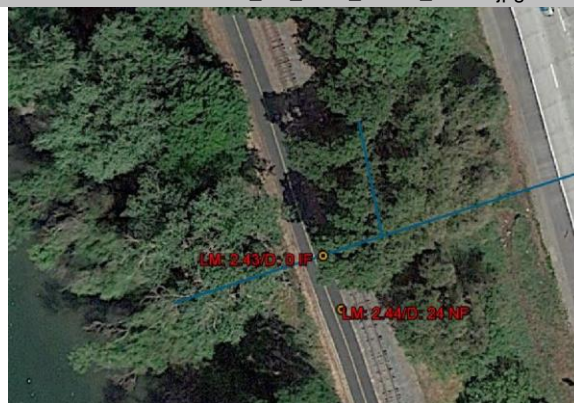
Photo 1 of 1 : UCIP_SP_2016_41296_72767.jpg

LM Start	2.43	Rating **	M	Issue No.	860
LM End	2.43	Issue Type +	En	Location *	WS
Category	Supplemental			GPS Latitude/Longitude	
				Start	End
Item	DWR UCIP Field Study			38.558224 °	38.558224 °
				-121.514365 °	-121.514365 °
DWR ID					
Comment Code					
Inspector Comment					
FS_ID:41296 DS_ID:24927 EP_NO: N/A Repair Type: Non-Urgent Crossing Status: Indicator Found UCIP Comments: Need to coordinate with owner to determine status of crossing--unable to locate in field. FIELD_STRUCT_DESC: 18 inch storm drain at unknown depth. Crossing information was obtained from Sacramento County GIS records. FS Date: 3/6/2013

Approximate alignment of crossing provided by the City of Sacramento.

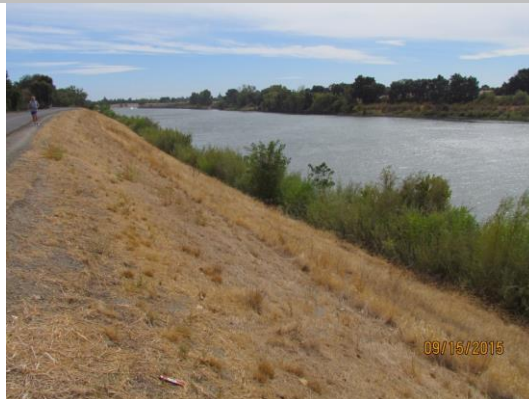
Photo 1 of 2 : SP_2016_NA0005_251_21_20160304_00012.jpg

LM Start	2.46	Rating **	A/W	Issue No.	21
LM End	2.75	Issue Type +	Ob	Location *	WS
Category	Earthen Levee			GPS Latitude/Longitude	
				Start	End
Item	Vegetation			38.557828 °	38.553710 °
				-121.514193 °	-121.512863 °
DWR ID	DWR_NA0005_01_s _ 2012_21				
Comment Code					
V8 : Environmental Requirements.					
Inspector Comment					
Revegetation site is at the toe of the levee on the waterward side.

View of the revegetation site on the waterward side looking downstream.
Fall 2015.

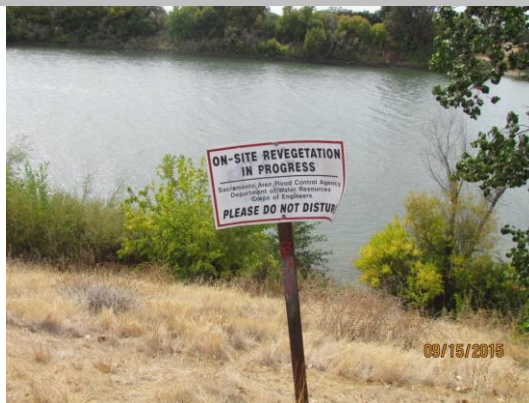
Photo 2 of 2 : SP_2016_NA0005_251_21_20160304_00013.jpg

This area is a revegetation site. Fall 2015.

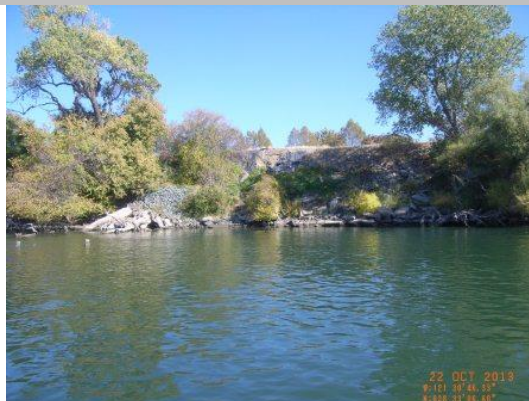
Photo 1 of 1 : SP_2016_NA0005_251_2_20160304_00003.jpg

LM Start	2.85	Rating **	M	Issue No.	2
LM End	2.90	Issue Type +	Ma	Location *	WS
Category	Supplemental			GPS Latitude/Longitude	
				Start	End
Item	2015 USACE Erosion Survey, DRAFT			38.552268 °	38.551578 °
				-121.512590 °	-121.512336 °
DWR ID	DWR_NA0005_01_s _ 2016_2				
Comment Code					
Inspector Comment					
1997 - Erosion at pump station, concrete debris and plastic showing. 2000 - Separation scour of bank due to poor transition. 2004 - New large tree pop out; city dumped fill dirt/rock into hole. 2006 - Minor new erosion at top of bank. 2010 - Some new rock placed in tree pop-out. 2011 - A large tree has fallen and flood fighting was performed by the city on the upper levee slope. 2012 - Small rock placed in hole from tree popout. 2015: No observed changes. [2015 Site ID: SAC 56-6 L]

USACE 2013 Photo #1

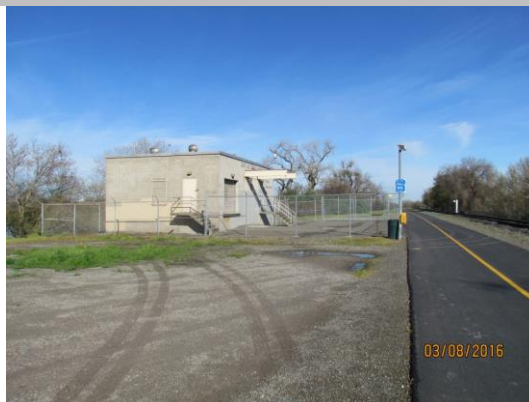
Photo 1 of 1 : SP_2016_NA0005_251_10_20160308_00118.jpg

LM Start	2.89	Rating **	M	Issue No.	10
LM End	2.89	Issue Type +	En	Location *	CR
Category	Earthen Levee			GPS Latitude/Longitude	
				Start	End
Item	Encroachments			38.551810 °	38.551810 °
				-121.511838 °	-121.511838 °
DWR ID	DWR_NA0005_01_s _ 2012_10				
Comment Code					
BU : Building					
Inspector Comment

View of the City of Sacramento pump station on the waterward side of the levee looking upstream. Spring 2016.

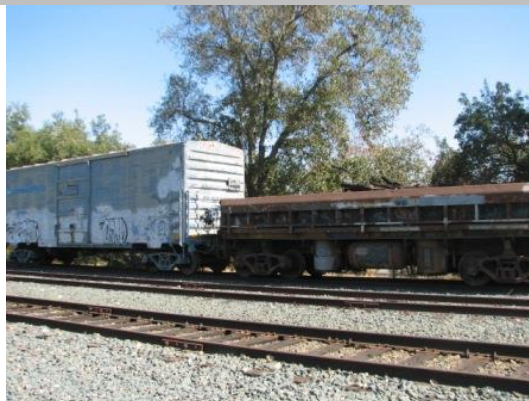
Photo 1 of 1 : SP_2016_NA0005_251_9_20160304_00008.jpg

LM Start	3.29	Rating **	M	Issue No.	9
LM End	3.29	Issue Type +	En	Location *	CR
Category	Earthen Levee			GPS Latitude/Longitude	
				Start	End
Item	Encroachments			38.546302 °	38.546302 °
				-121.510197 °	-121.510197 °
DWR ID	DWR_NA0005_01_f_2013_9				
Comment Code					
EQ : Equipment					
Inspector Comment					
There are four cars on the levee crown.

Trains cars are stored on the crown of the levee. Fall 2013

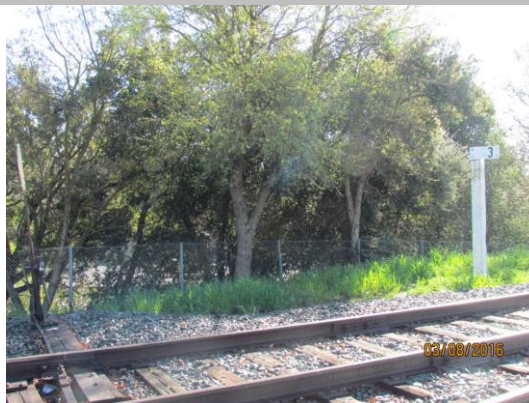
Photo 1 of 2 : SP_2016_NA0005_251_85_20160308_00119.jpg

LM Start	3.35	Rating **	M	Issue No.	85
LM End	3.35	Issue Type +	Ma	Location *	LS
Category	Earthen Levee			GPS Latitude/Longitude	
				Start	End
Item	Trim / Thin Trees			38.545403 °	38.545403 °
				-121.509830 °	-121.509830 °
DWR ID	DWR_NA0005_01_s_2016_85				
Comment Code					
T3 : Trim and thin trees to allow visibility of the ground and room to flood fight.					
Inspector Comment

View of the trees on the landward side of the levee. Spring 2016.
